Inspection Report

Property Address:
1234 Any Street
Anywhere Arizona 85295

Bullseye Inspections

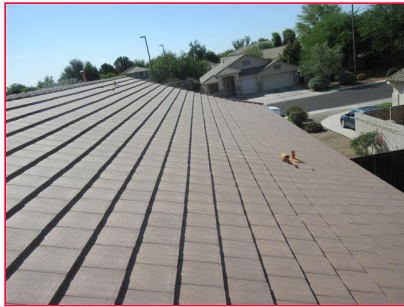
A concrete tile roof system is present over all or the majority of roof structure. No concrete tile roof cover can be 100% water tight due to the decorative nature of the material. The underlayment, which in most applications is thirty to forty pound felt paper is the important moisture barrier between the tile and roof sheathing. An underlayment of mineral paper cap sheet can also be utilized and is considered an upgrade. The life span of the tile themselves can be up to fifty years. However, felt paper underlayment will last approximately twenty to twenty five years depending on climate and roof structure ventilation. The roof appears to be in the last third of its useful life. Periodic maintenance and replacement of the underlayment when needed will maximize the life of a concrete tile roof cover. Roof appears to be ok except for the noted items, the roof coverings showed no visible signs of any deficiencies on the day of the inspection. There are broken tiles at various locations leaving the felt underlayment exposed. A qualified roofing contractor should review the roof covers and repair, replace tiles / underlayment as necessary.

4.0 Item 1(Picture) South facing roof covering

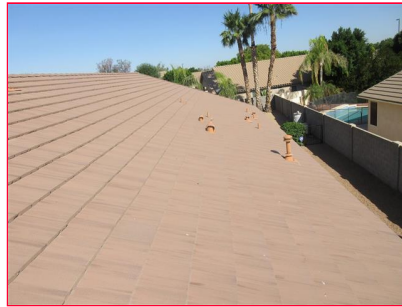
4.0 Item 2(Picture) North facing roof covering

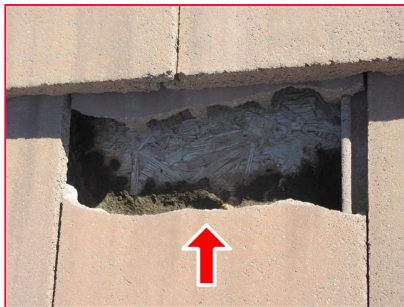
4.0 Item 4(Picture) Broken tile and damaged/exposed underlayment

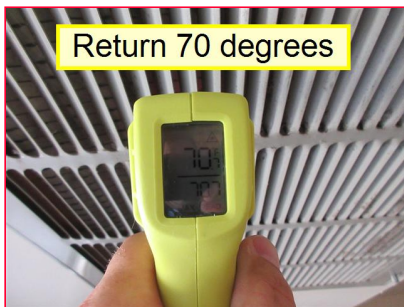
The ambient air test was performed on the air conditioner to determine if the difference in temperatures at the supply and return air ducts was between 17 degrees and 22 degrees. This temperature differential will indicate if the unit is cooling as intended. The supply air temperature on your system read 54 degrees, and the return air temperature was 70 degrees. This indicates that the unit is ***not cooling properly*** and a licensed Heat/Air contractor should evaluate the system for service / repair.

7.4 Item 1(Picture) Return Temperature

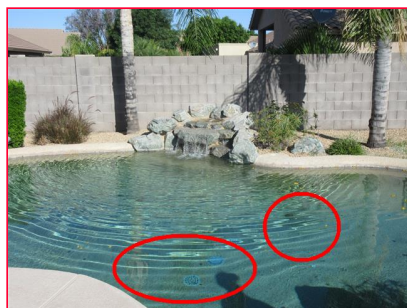
Anti-vortex drain covers are not installed on this pool/spa installation. A swimmer's hair or could be caught in the drain. For pool safety, all pool/spa drains equipped with flat drain grates should be upgraded with anti-vortex drain covers. No one should be in the pool unattended. A qualified technician should do the work.

15.0 Item 1(Picture) No anti-vortex covers

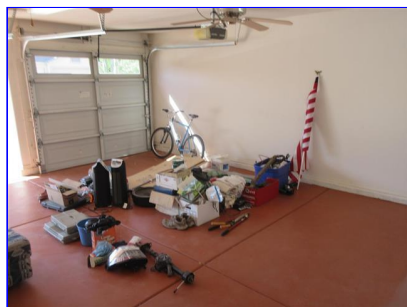
9.0 Item 1(Picture)

Inspection of this area was limited to the surface coverings. The construction materials and manner of installation are inaccessible and concealed from view.

Personal belongings prevented full access to the garage at the time of this inspection. A walk-through is recommended when the area is cleared and accessible.

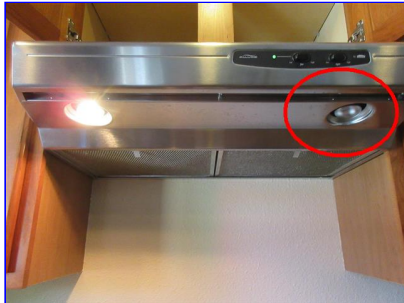
The light at the exhaust fan/range hood did not work when tested. We did not change the bulb to verify that it was just a burned out bulb. I recommend replacing the bulb. If the light still does not work, I suggest having a qualified person make further evaluations and repairs as needed.

11.7 Item 1(Picture) Recommend replacing bulb

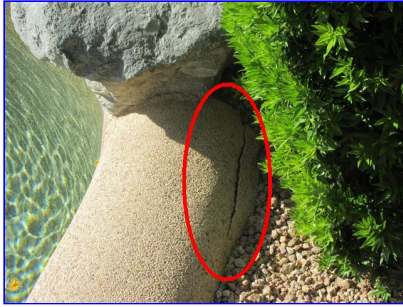
The pool and or spa decking shows typical cracks and wear. Any missing, chipped or cracks are cosmetic and can be repaired. The pool and or spa decking shows typical cracks and wear. Any missing, chipped or cracks are cosmetic and can be repaired.

15.1 Item 1(Picture) Cracked coping

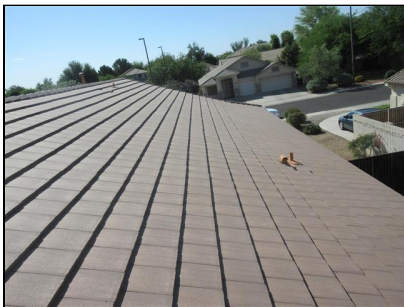
4.0 A concrete tile roof system is present over all or the majority of roof structure. No concrete tile roof cover can be 100% water tight due to the decorative nature of the material. The underlayment, which in most applications is thirty to forty pound felt paper is the important moisture barrier between the tile and roof sheathing. An underlayment of mineral paper cap sheet can also be utilized and is considered an upgrade. The life span of the tile themselves can be up to fifty years. However, felt paper underlayment will last approximately twenty to twenty five years depending on climate and roof structure ventilation. The roof appears to be in the last third of its useful life. Periodic maintenance and replacement of the underlayment when needed will maximize the life of a concrete tile roof cover. Roof appears to be ok except for the noted items, the roof coverings showed no visible signs of any deficiencies on the day of the inspection. There are broken tiles at various locations leaving the felt underlayment exposed. A qualified roofing contractor should review the roof covers and repair, replace tiles / underlayment as necessary.

4.0 Item 1(Picture) South facing roof covering

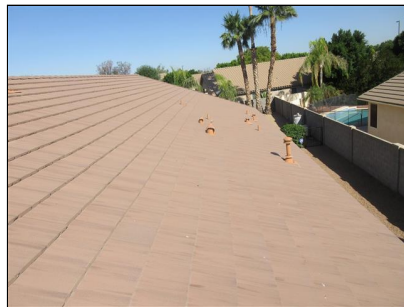
4.0 Item 2(Picture) North facing roof covering

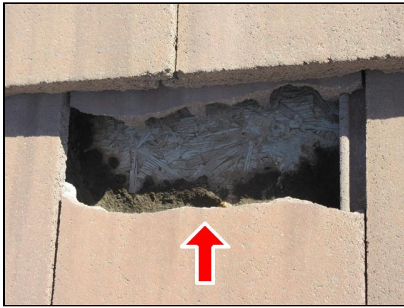
4.0 Item 4(Picture) Broken tile and damaged/exposed underlayment

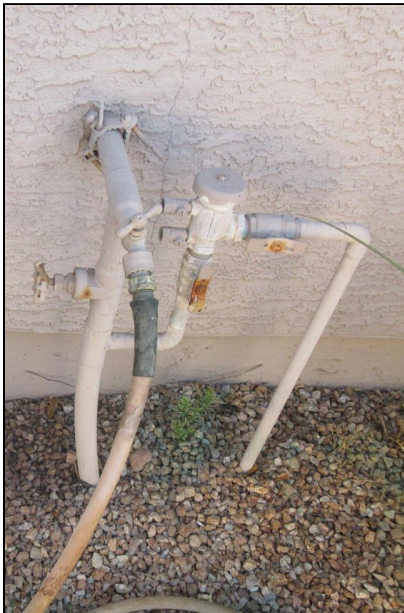
5.1 The photos show your shut off device at the buildings exterior and water meter box. The meter was not moving indicating that a leak in the supply lines is not present. While this does not guarantee that no leaks do or will exist it is the best that can be provided during a visual inspection.

5.1 Item 1(Picture) Water main shut-off southeast front corner of home

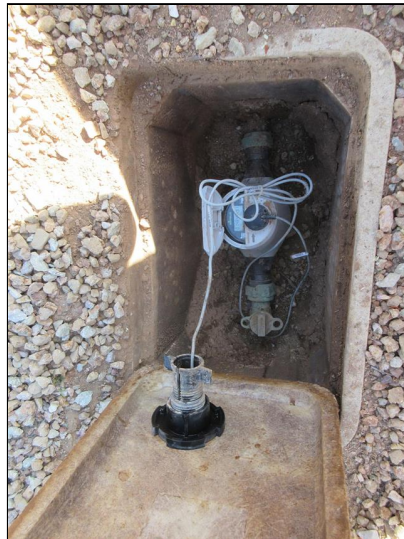
5.1 Item 2(Picture) Main water meter southeast front corner of home

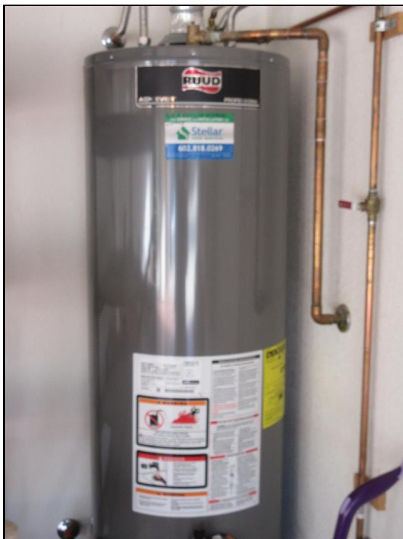
5.5 The gas fired water heater performed it's intended function, and showed no signs of leaking and or distress, on the day of the inspection. NOTE: The normal useful life of most water heating systems is 8 to 10 years. This unit is between 1-5 years old and is a 40 gallon unit.

5.5 Item 1(Picture) RUUD Water Heater

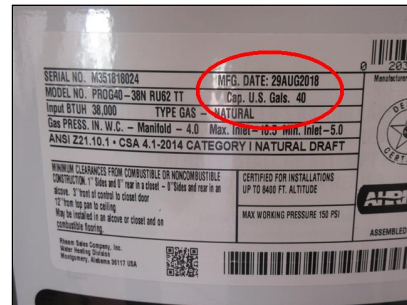
5.5 Item 3(Picture) Water heater MFG 2008 and is 40 Gals

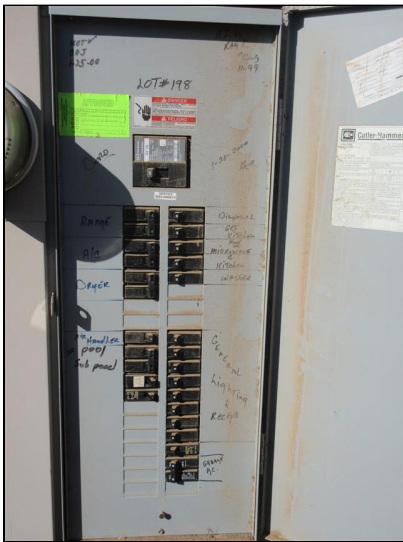
6.2 No deficiencies were noted in the main service panel at time of inspection.

6.2 Item 1(Picture) Labeled Dead-front panel

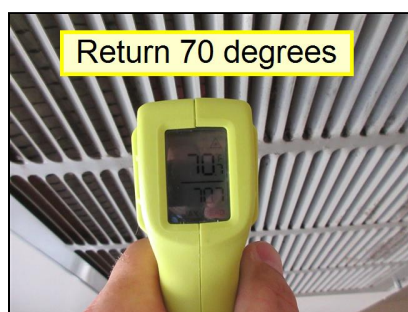
7.4 The ambient air test was performed on the air conditioner to determine if the difference in temperatures at the supply and return air ducts was between 17 degrees and 22 degrees. This temperature differential will indicate if the unit is cooling as intended. The supply air temperature on your system read 54 degrees, and the return air temperature was 70 degrees. This indicates that the unit is **not cooling properly** and a licensed Heat/Air contractor should evaluate the system for service / repair.

7.4 Item 1(Picture) Return Temperature

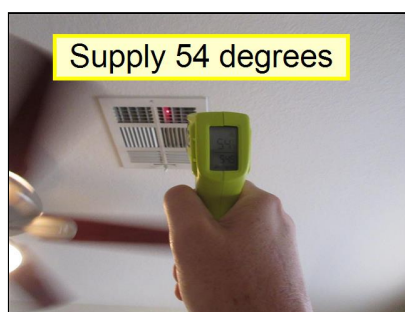
7.4 Item 2(Picture) Supply Temperature

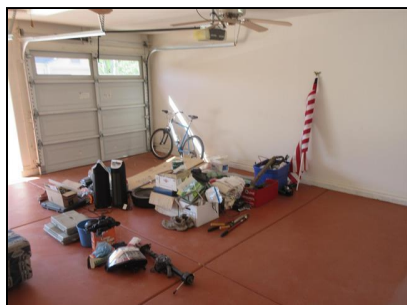
9.0 Item 1(Picture)

9.0 Inspection of this area was limited to the surface coverings. The construction materials and manner of installation are inaccessible and concealed from view.

Personal belongings prevented full access to the garage at the time of this inspection. A walk-through is recommended when the area is cleared and accessible.

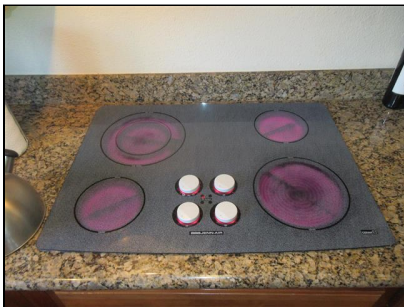
11.3 Item 1(Picture)

11.3 The burners and oven elements operated normally at time of inspection.

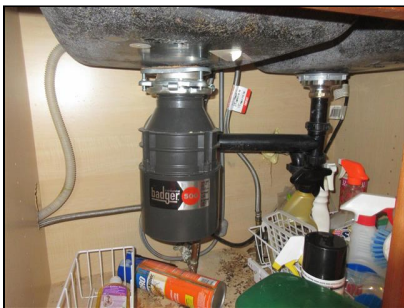
11.5 Item 1(Picture)

11.5 The disposal(s) was operated and functioned normally at time of inspection.

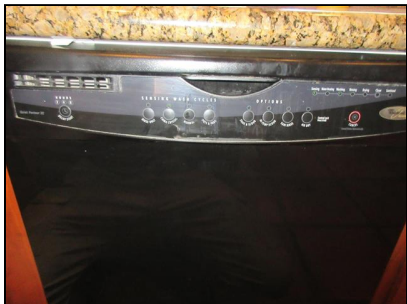
11.6 Item 1(Picture)

11.6 During the inspection of the Dishwasher we only check the running cycles, Physical parts visible and the draining system. Checking of the Drying system is beyond the scope of this inspection.No leaks noted at time of inspection.

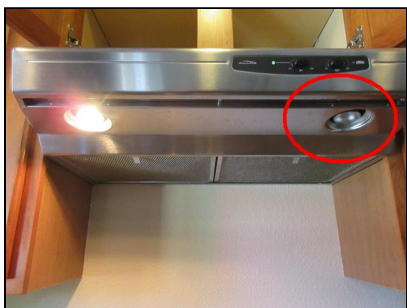
The light at the exhaust fan/range hood did not work when tested. We did not change the bulb to verify that it was just a burned out bulb. I recommend replacing the bulb. If the light still does not work, I suggest having a qualified person make further evaluations and repairs as needed.

11.7 Item 1(Picture) Recommend replacing bulb

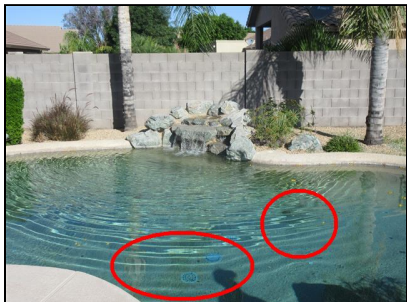
Anti-vortex drain covers are not installed on this pool/spa installation. A swimmer's hair or could be caught in the drain. For pool safety, all pool/spa drains equipped with flat drain grates should be upgraded with anti-vortex drain covers. No one should be in the pool unattended. A qualified technician should do the work.

15.0 Item 1(Picture) No anti-vortex covers

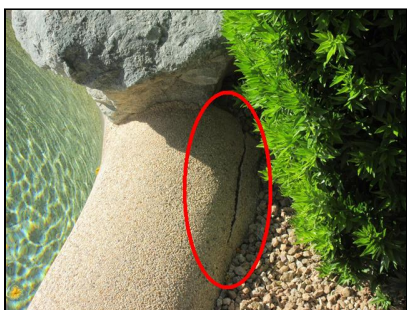
15.1 The pool and or spa decking shows typical cracks and wear. Any missing, chipped or cracks are cosmetic and can be repaired. The pool and or spa decking shows typical cracks and wear. Any missing, chipped or cracks are cosmetic and can be repaired.

15.1 Item 1(Picture) Cracked coping

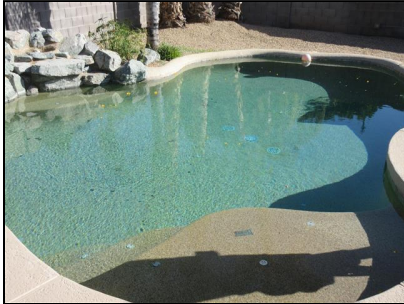
15.2 Item 1(Picture)

15.2 The pool and or spa vessel surface material was in acceptable condition and showed no signs of any major flaws on the day of the inspection. Typical cosmetic wear was observed.

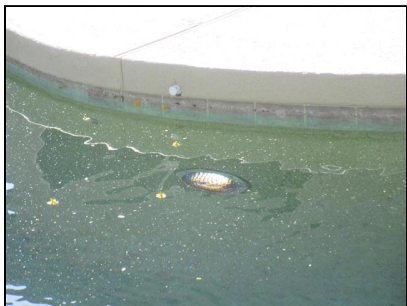
15.8 The pool light, GFCI protection for pool light and all wiring were intact and functional at time of inspection.

15.8 Item 1(Picture) Pool light functional
